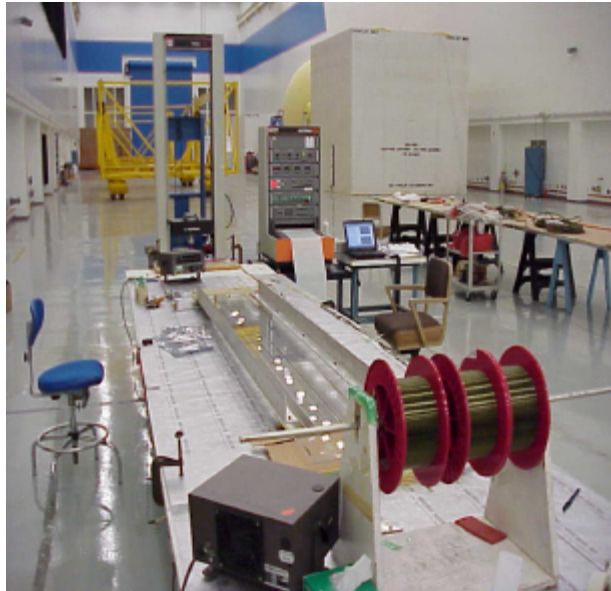
Figure 29 Test Set-up

Fiber which had not been cabled and which had been cabled were strength tested. Fiber, which had never been processed by BICC, was tested before and throughout the cabling process to understand how each step of that process affects the strength of the fiber. The testing was performed in accordance with EIA Fiber Optic Test Procedure 28, EIA-TIA-455-28B, "Method for Measuring Dynamic Tensile Strength of Optical Fiber". The set-up is shown in Figure 29. When the test was run on cabled fiber, as much of the cable was left intact as possible during the test and laser light was used to identify the locations of the breaks inside of the cable. Table 8 shows the gauge lengths and pull conditions used on the various samples. The cable and fiber that was available from which samples were selected, had already been proof tested to 141 kpsi and screened optically for the "rocket engine" defects. This provided some confidence that no large defects of that kind would factor into the strength data. For high strength samples, the breaks were expected to occur between the range of 11.2 to 12.7 lbs, based on the set-up, loading and the intrinsic strength of the fiber (> 450 kpsi). The resulting data would be plotted as a Weibull distribution which was expected to be bi-modal, one slope expected for the high strength breaks and one for the low strength breaks caused by a defect.

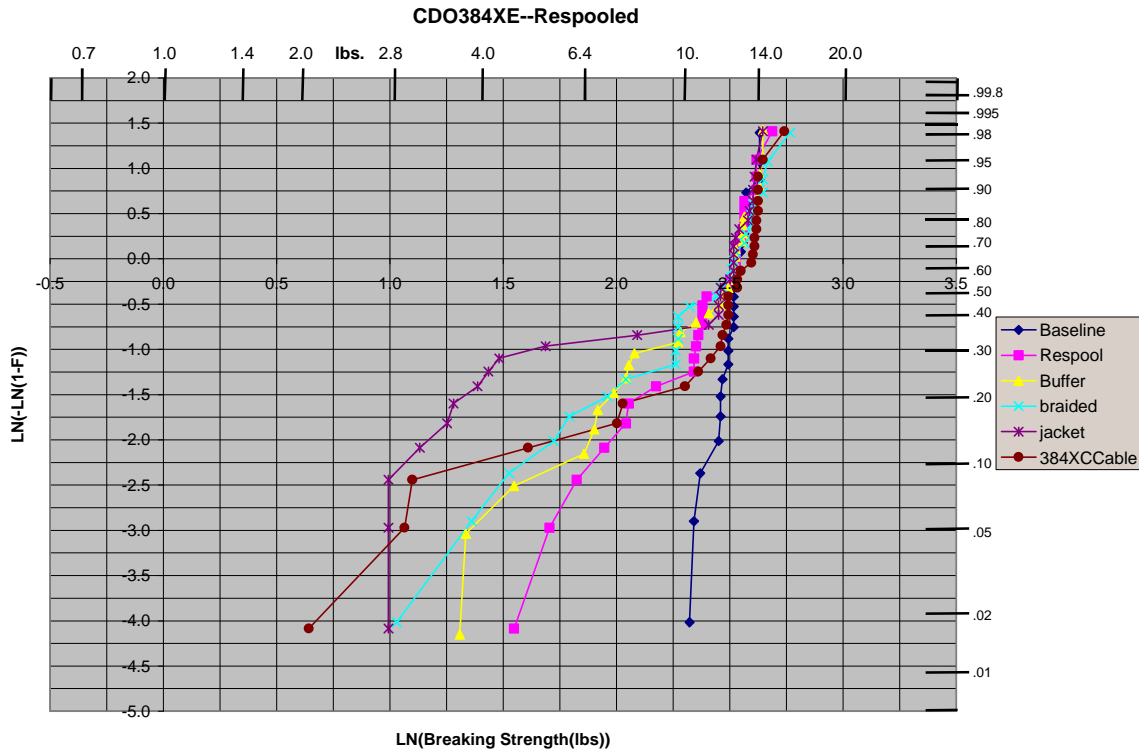
a.

The results of the second round of strength testing are shown in Figures 32a through 32d. [ref-22, 23, 24]
Figures 33a through 33d show the endfaces of the fibers at the low strength breaks.
